Manhole Inspection Summary

Manhole # S15WW_015MH

Location Address: **3300 DRUID PARK DR**

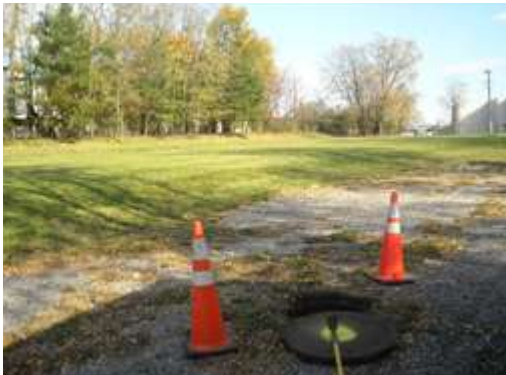
Location View

Comments **MH located in gravel path**

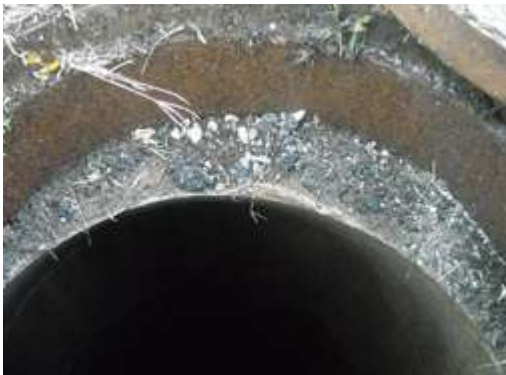
Defect 1

Frame Offset: **4** (in.) Condition: ☒ Sound ☐ Cracked ☐ Leaks

FRAME OFFSET

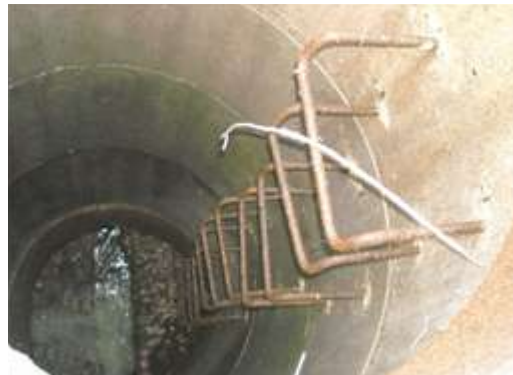
Defect 2

Steps Count: **12** Missing: **0** ☒ **Corroded**

CORRODED STEPS

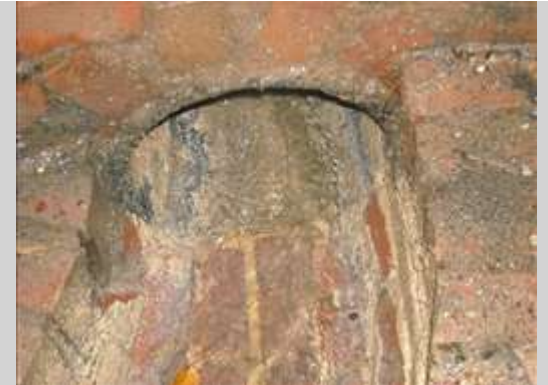
12 O'Clock Outflow

10 in. Circular Gravity Sewer
Pipe Out @ 12 O'Clock

Pipe Height: **9.6** (in.) Rod and Bar (Angled)
Pipe Material: **Clay** ☐ Pipe Lined
Invert Depth: **16.61** (ft.) Flow Characteristics: **Fast**
Deposits: ☒ None ☐ Mud ☐ Sludge ☐ Debris ☐ Grease
Silt Depth: (in.) Deposits Extent:
Infiltration: **None** Pipe Seal Cond: **Sound**

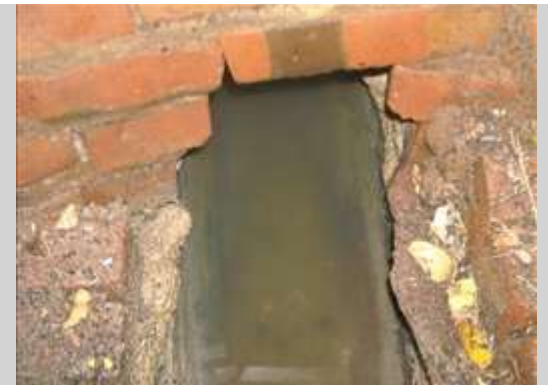
3 O'Clock Outflow

10 in. Circular Gravity Sewer
Pipe Out @ 3 O'Clock

Pipe Height: **10.8** (in.) Rod and Bar (Angled)
Pipe Material: **Clay** ☐ Pipe Lined
Invert Depth: **16.29** (ft.) Flow Characteristics: **Slow**
Deposits: ☒ None ☐ Mud ☐ Sludge ☐ Debris ☐ Grease
Silt Depth: (in.) Deposits Extent:
Infiltration: **None** Pipe Seal Cond: **Sound**

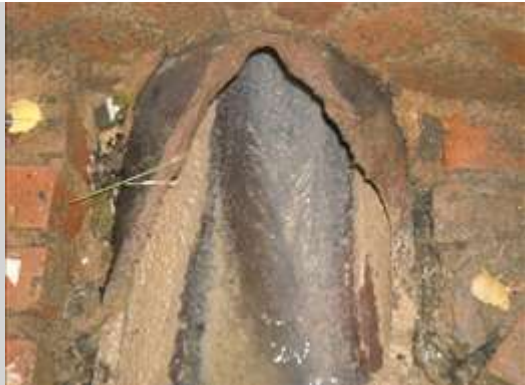
9 O'Clock Inflow

10 in. Circular Gravity Sewer
Pipe In @ 9 O'Clock

Infiltration: **None** Pipe Seal Cond: **Broken**
